High-Definition Metrology and Vision Application Note #09-04

Wheel Bearing Failures Solved - - A *ShaPix* Case Study

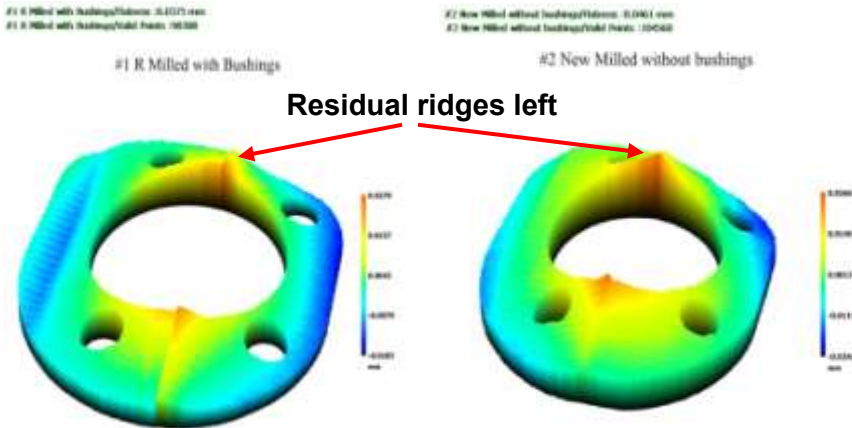
ShaPix measurements showed the flatness for the trailing arm mounting face (MF) to be well out of specification. Several additional trailing arms on failed units were brought to Coherix on the next day and these also measured in the 300 – 350 micron range for overall flatness. It was determined that the trailing arm MF needed an additional milling step to bring the flatness into specification. An additional milling step was added to the Trailing Arm manufacturing process, with initial results transported to Coherix on the same day for measurement. ShaPix showed that the overall flatness had been reduced to approx: 40 – 50 microns, but that the 2 pass milling operation was leaving an uneven ridge in the middle of the part.

A single-pass milling operation replaced the 2 pass operation. The next day, Coherix measurement results showed that the overall flatness had been reduced to approx: 18 microns. Additional trailing arms were measured for long term testing.

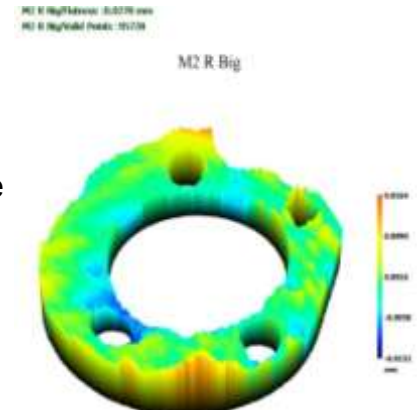
The final step in testing of the new process was to measure the Trailing Arm Mounting Face after it was painted, which is the final step in manufacturing. Parts were measured at Coherix on the third day. The results showed that the overall flatness was approx: 27 microns, within specifications, so launch was re-started.
