High-Definition Metrology and Vision Application Note #09-05

Detection of an Incoming Part Casting Defect - a *ShaPix* Case Study

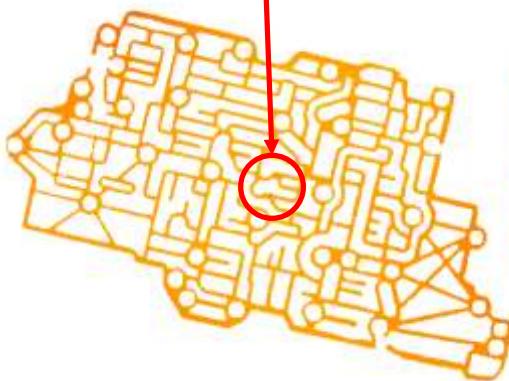
ShaPix detected an area that was much lower than the surrounding area, failing the part for flatness and zone flatness (the CMM had passed the part)

Standard casting without notch

Casting with notch

Machining was halted on the valve bodies. Investigation by production personnel discovered the problem on castings with two specific die identifiers. The casting supplier and product engineering was notified of the problem. **OEM2** production management then rejected all castings from those dies. They were purged from the system including assembly and returned to supplier. No rejected parts made it into saleable transmissions.

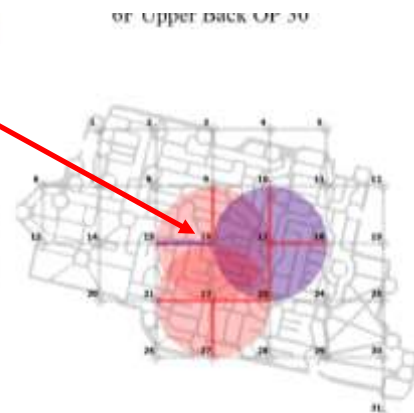
Point	Flatness (mm)
1	0.0099
2	0.0093
3	0.0094
4	0.0093
5	0.0093
6	0.0093
7	0.0093
8	0.0094
9	0.0177
10	0.0091
11	0.0090
12	0.0074
13	0.0041
14	0.0040
15	0.0041
16	0.0098
17	0.1501
18	0.1801
19	0.0098
20	0.0096
21	0.0096
22	0.1803
23	0.0048
24	0.0072
25	0.0048
26	0.0093
27	0.0093
28	0.0091
29	0.0047
30	0.0091
31	0.0093
