High-Definition Metrology and Vision Application Note #09-07

Diagnosis of Transmission Pump Assembly Issue - a ShaPix Case Study

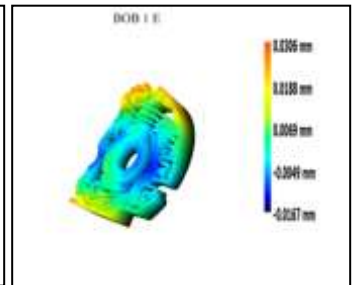
Shaft/flange bolted down

The **ShaPix** measurements clearly revealed a distortion of the pump assembly face occurring during the final phase of the assembly when the retaining flange was bolted down to the pump housing. This distortion was causing leakage and eventual failure. **ShaPix** provided the root cause failure analysis information to guide the corrective action plan – the fastening of the flange to the back of the valve body. A directional and distortion shift of the pump face sealing surface of 0.0503 millimeters was determined to be occurring from the **ShaPix** measurement.

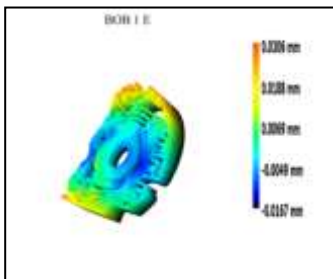
Leak tested

The final assembly of the pump cover, shaft/bearing and flange had shown that the end result was assemblies that produced leakage failures. It was not understood where in the machining or assembly process distortion has been created..

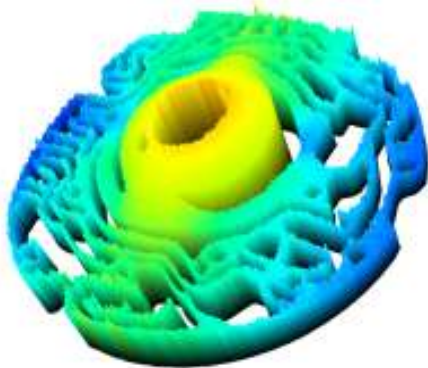
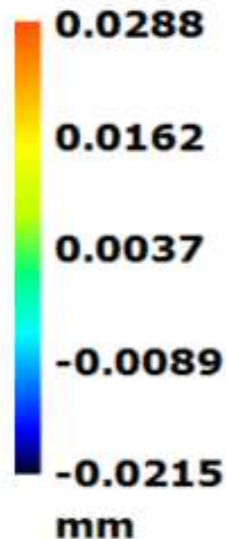
Difference in pump cover shape between final machining complete and flange bolted down

The **ShaPix** high-definition measurement data showed a total peak to peak deviation after final tightening down of the shaft mounting flange of 50.3 microns.
