High-Definition Metrology and Vision Application Note #09-08

Diagnosis of an Engine Machining Process Problem - a *ShaPix* Case Study

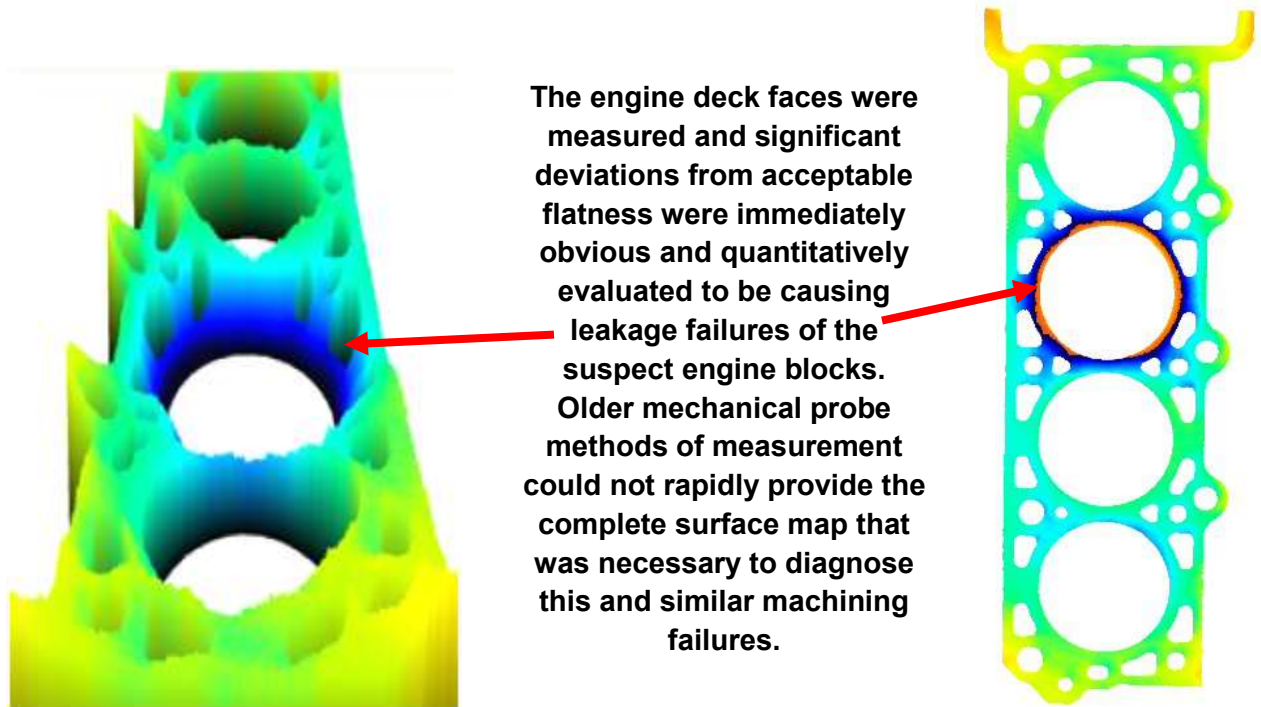
The **ShaPix** comprehensive output data and short measurement time allowed the OEM to rapidly identify the root-cause of the engine failures. The **ShaPix** operator interface allowed the user to quickly isolate regions of interest to facilitate root cause analysis for the engine failures in the field. The visual data allowed the user to understand the interactions between the part and the applicable machines (cutter profile, rotation speed, feed rate, feed direction, fixture integrity and rigidity, and coolant, etc). This relatively short measurement time allowed the process and tooling engineers to efficiently conduct a series of experiments to improve the manufacturing process. The **ShaPix** user-configurable zone flatness feature allowed the user to quickly identify the localized regions where leakages were likely to occur.

From the **ShaPix** measurement data, it was possible to rapidly determine that the root cause of failures was the use of excessively worn tools in one stage of the machining process.
