High-Definition Metrology and Vision Application Note #09-04

Wheel Bearing Failures Solved - - A *ShaPix* Case Study

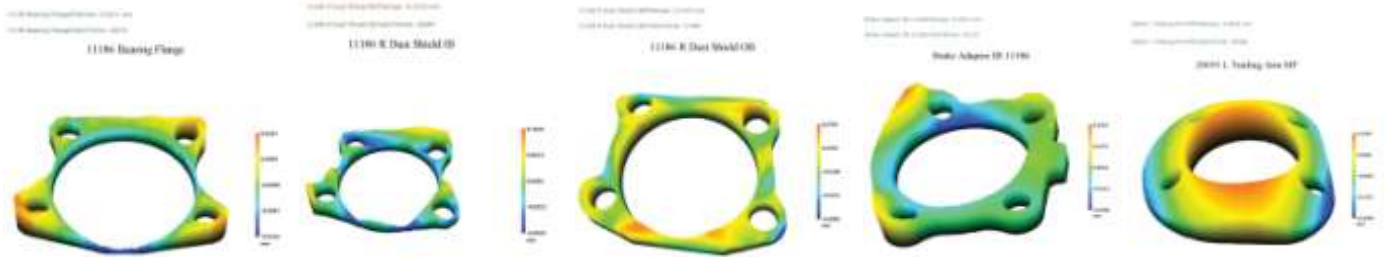
Immediate feedback was provided to the OEM engineering team members who were present.

ShaPix measurements showed the flatness for the trailing arm mounting face (MF) to be well out of specification. Several additional trailing arms on failed units were brought to Coherix on the next day and these also measured in the 300 – 350 micron range for overall flatness. It was determined that the trailing arm MF needed an additional milling step to bring the flatness into specification. An additional milling step was added to the Trailing Arm manufacturing process, with initial results transported to Coherix on the same day for measurement. ShaPix showed that the overall flatness had been reduced to approx: 40 – 50 microns, but that the 2 pass milling operation was leaving an uneven ridge in the middle of the part.

A single-pass milling operation replaced the 2 pass operation. The next day, Coherix measurement results showed that the overall flatness had been reduced to approx: 18 microns. Additional trailing arms were measured for long term testing.
