High-Definition Metrology and Vision Application Note #09-05

Detection of an Incoming Part Casting Defect - a *ShaPix* Case Study

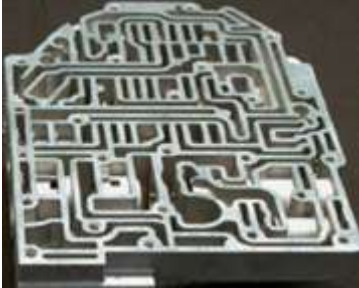
In a transmission plant of a *Coherix* OEM customer, (“OEM2”), a *ShaPix* being used to audit machined parts detected a small area that was much lower at a particular point on the machined surface separating two fluid channels (“worm trails”) near the center of the part. The lower area was in the same location on all parts that failed tests in this way. When *ShaPix* detected an area that was much lower than the surrounding area, it rejected the part for global and zone flatness. The CMM had passed the part. Upon visual examination of the parts, no low area was apparent at that location.

An archived part used in long term reference testing of the *ShaPix* was retrieved and compared to the part being measured. There was a difference in the castings of the parts in the area of interest. Further checking of parts in the production area determined that the die used for casting them was different than all other dies used to cast parts. It had a notched surface between the “worm trails” in the area of interest and all others had a straight trail.

The casting supplier uses “jigsaw puzzle” type die inserts. Small sections of these dies can be replaced to produce different worm trail configurations. This transmission is produced by both another original Equipment Manufacturer OEM (“**OEM1**”) and **OEM2**, and the supplier provides castings for both companies. **OEM1** had made a small change in the worm trail design for their version of the transmission. But the casting supplier had failed to change two dies to the **OEM2** configuration before casting parts for them. So it incorrectly shipped many **OEM1** castings to **OEM2**. No outgoing testing at the supplier or incoming testing at **OEM2** was in place to verify that the correct parts were produced and shipped.

ShaPix detected an area that was much lower than the surrounding area, failing the part for flatness and zone flatness (the CMM had passed the part)
