High-Definition Metrology and Vision Application Note #09-08

Diagnosis of an Engine Machining Process Problem - a *ShaPix* Case Study

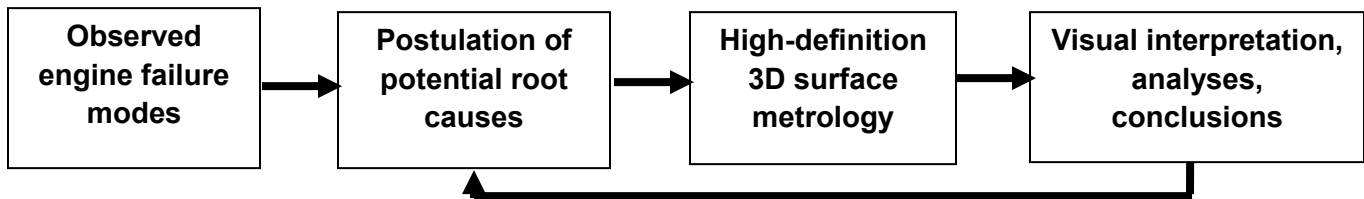
It was necessary to measure the flatness of the entire engine deck face to an accuracy of approximately 1 micron in order to diagnose the issues leading to engine failure. Both measurement of global surface characteristics and high-definition measurement of local surface flatness in critical surface areas were required.

The ability to see and immediately understand, in visually obvious detail, the surface characteristics of the engine deck faces for failed and newly machined engines would be a vital weapon in being able to rapidly home in on the root causes of the engine failures. In addition the ability to define and implement new surface measurements within minutes would significantly reduce the elapsed time for reaching a final conclusion regarding the actual root causes of the failures.

From the **ShaPix** measurement data, it was possible to rapidly determine that the root cause of failures was the use of excessively worn tools in one stage of the machining process.
